Stripping a SUNBEAM

THIS STURDY SPORTING SALOON CAR WILL REPAY TIME SPENT ON PUTTING IT INTO TOP FORM.

mk.3

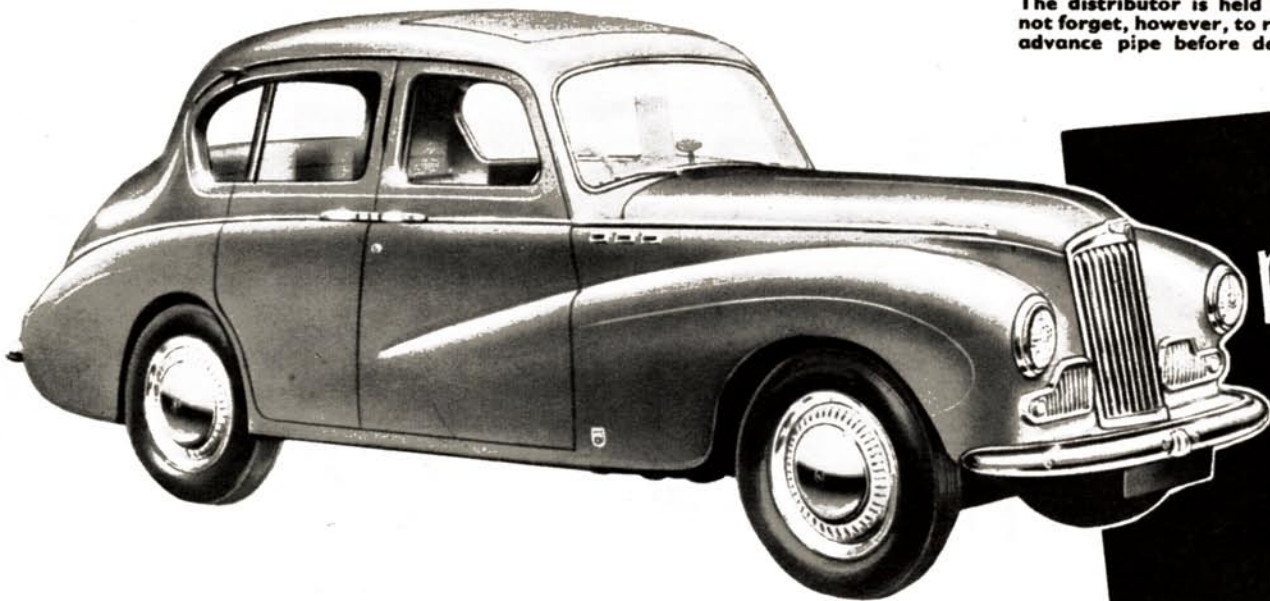
The car used for this PRACTICAL MOTORIST overhaul was a 1956 model which its second owner had purchased only a few weeks before. On examination, considerable

carbon formation was found in the carburettor, suggesting that one or more of the inlet valves was in dire need of attention.

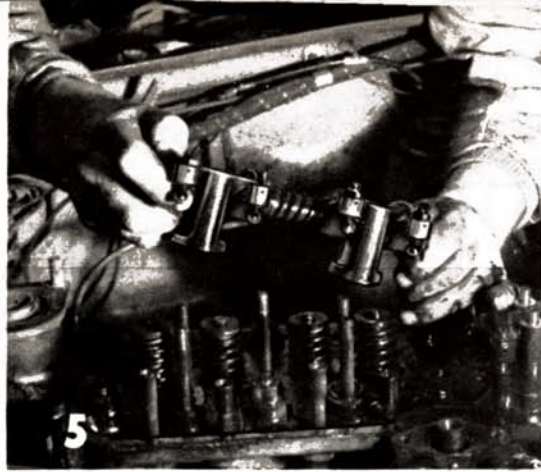
5

When removing the rocker gear, take care not to lose the two washers which lock the nuts. Be gentle with the pushrods, too.

There are eight nuts holding the rocker pillars, each with one spring and one flat washer. Once these had been undone ($\frac{1}{8}$ in. B.S.F. spanner) the rocker gear was lifted off. Next the pushrods were removed, each being gently eased out of place to avoid pulling the tappets out of their seatings in the block.

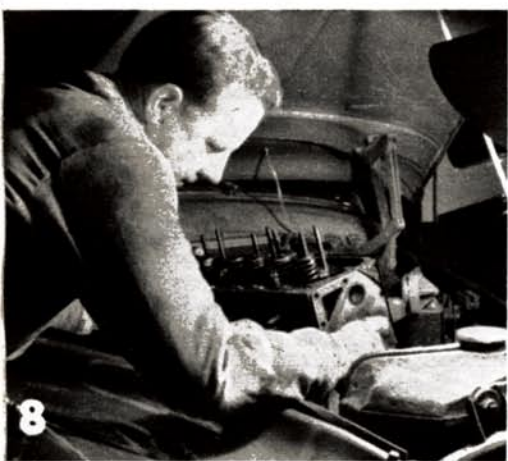
8

If the water pump is to be removed it is best done before the head is lifted. Space is limited. Ensure that your grip is firm.

Further ancillary dismantling followed—first the rear engine stabiliser bracket; then the cooling fan (held by four nuts requiring a $\frac{1}{2}$ in. B.S.F. spanner). The water pump, secured by six bolts, was also removed for examination. Normally, it should not be necessary to disturb it.

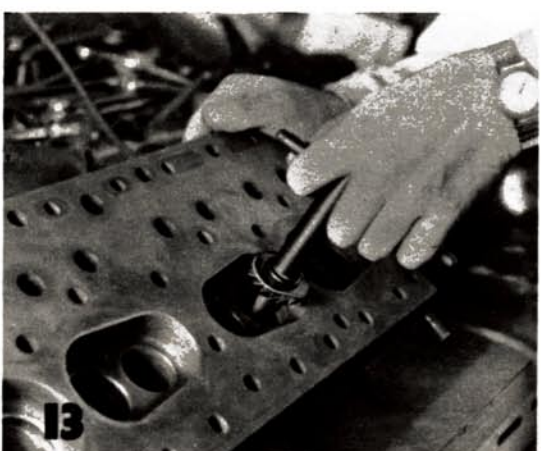
13

Really bad valve seats, such as that shown on this page, can only be treated by using a 45-degree cutter, to make a fresh seat.

Upon removal and examination, it was found that several of the valve seats were in poor condition and that all the valves had heavy carbon deposits on the stems. The seats were therefore recut, using a 45-deg. cutter, and each valve was first scraped clear of carbon and then its stem was polished with fine "wet-and-dry" emery. Afterwards, each was ground-in to the new-cut seat in the normal way.

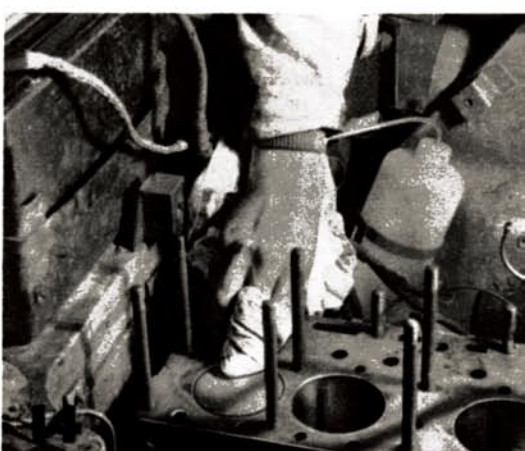
The pistons need not be taken out. Scrape the carbon off the crowns and then finish the job with metal polish. Wash with petrol.

The combustion chambers and the piston crowns had previously been cleared of carbon but before re-assembly the ports were thoroughly cleaned, using a wire brush and an electric drill, and the piston crowns polished with metal polish. They were then thoroughly washed with petrol.

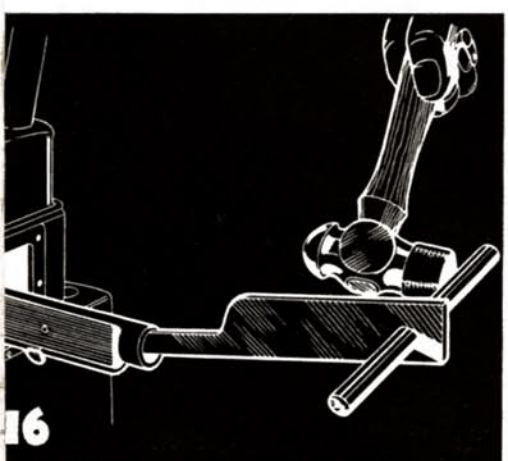
16

A special tool is needed to remove the tube. It can be made of 1/2 in. steel plate 1 in. deep. The hook is 3 1/2 x 1/8 in. Use it with a hammer.

On the head, both front and rear back plates were removed so that the coolant channels could be examined. A distribution tube is fitted to ensure an adequate flow to all areas liable to experience excessive heat, in particular the top of the exhaust valve seatings. Normally, this tube is not disturbed unless severe overheating has been experienced and blockage is suspected. To remove it, it is necessary to fabricate, from $\frac{1}{2}$ in. steel plate, a special hooked tool, with a shank $3\frac{1}{2}$ in. long and an extended handle. This tool connects with a hole in the lower surface of the distribution tube. By inserting a tommy bar through a hole in the handle the tube can be hammered out.

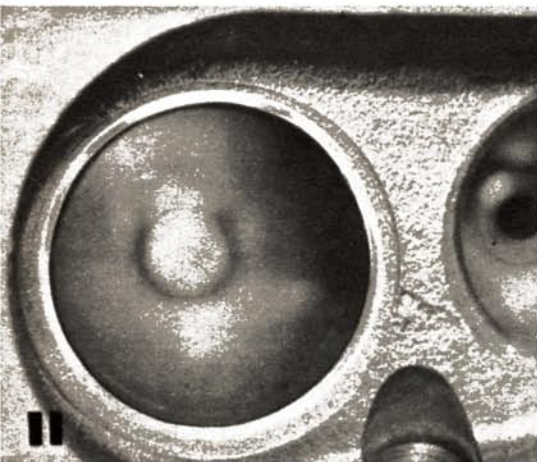
11
The same valve seat after it had been recut and the valve ground in. This is the standard at which to aim when overhauling.

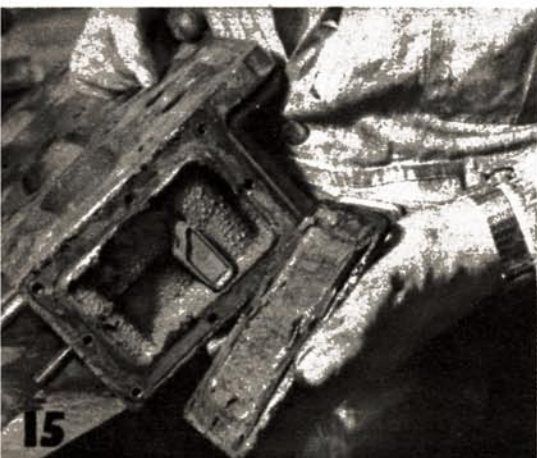
15
Fouling of the water passages may be suspected. Open up the plates on the head and check the internal distribution tube.

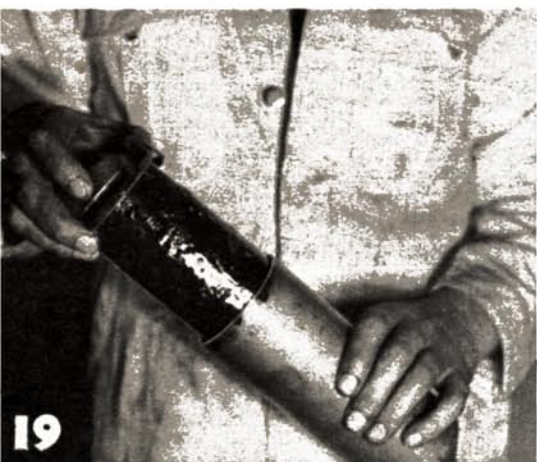
19
Finally, change the engine oil and fit a new filter element. A core which is in this condition is merely by-passed completely.
